Huntington Ridge Apartments Kelso, Washington

Preliminary Stormwater Management Report *February 6, 2020*

***Huntington Ridge Apartments
Preliminary Drainage Report***

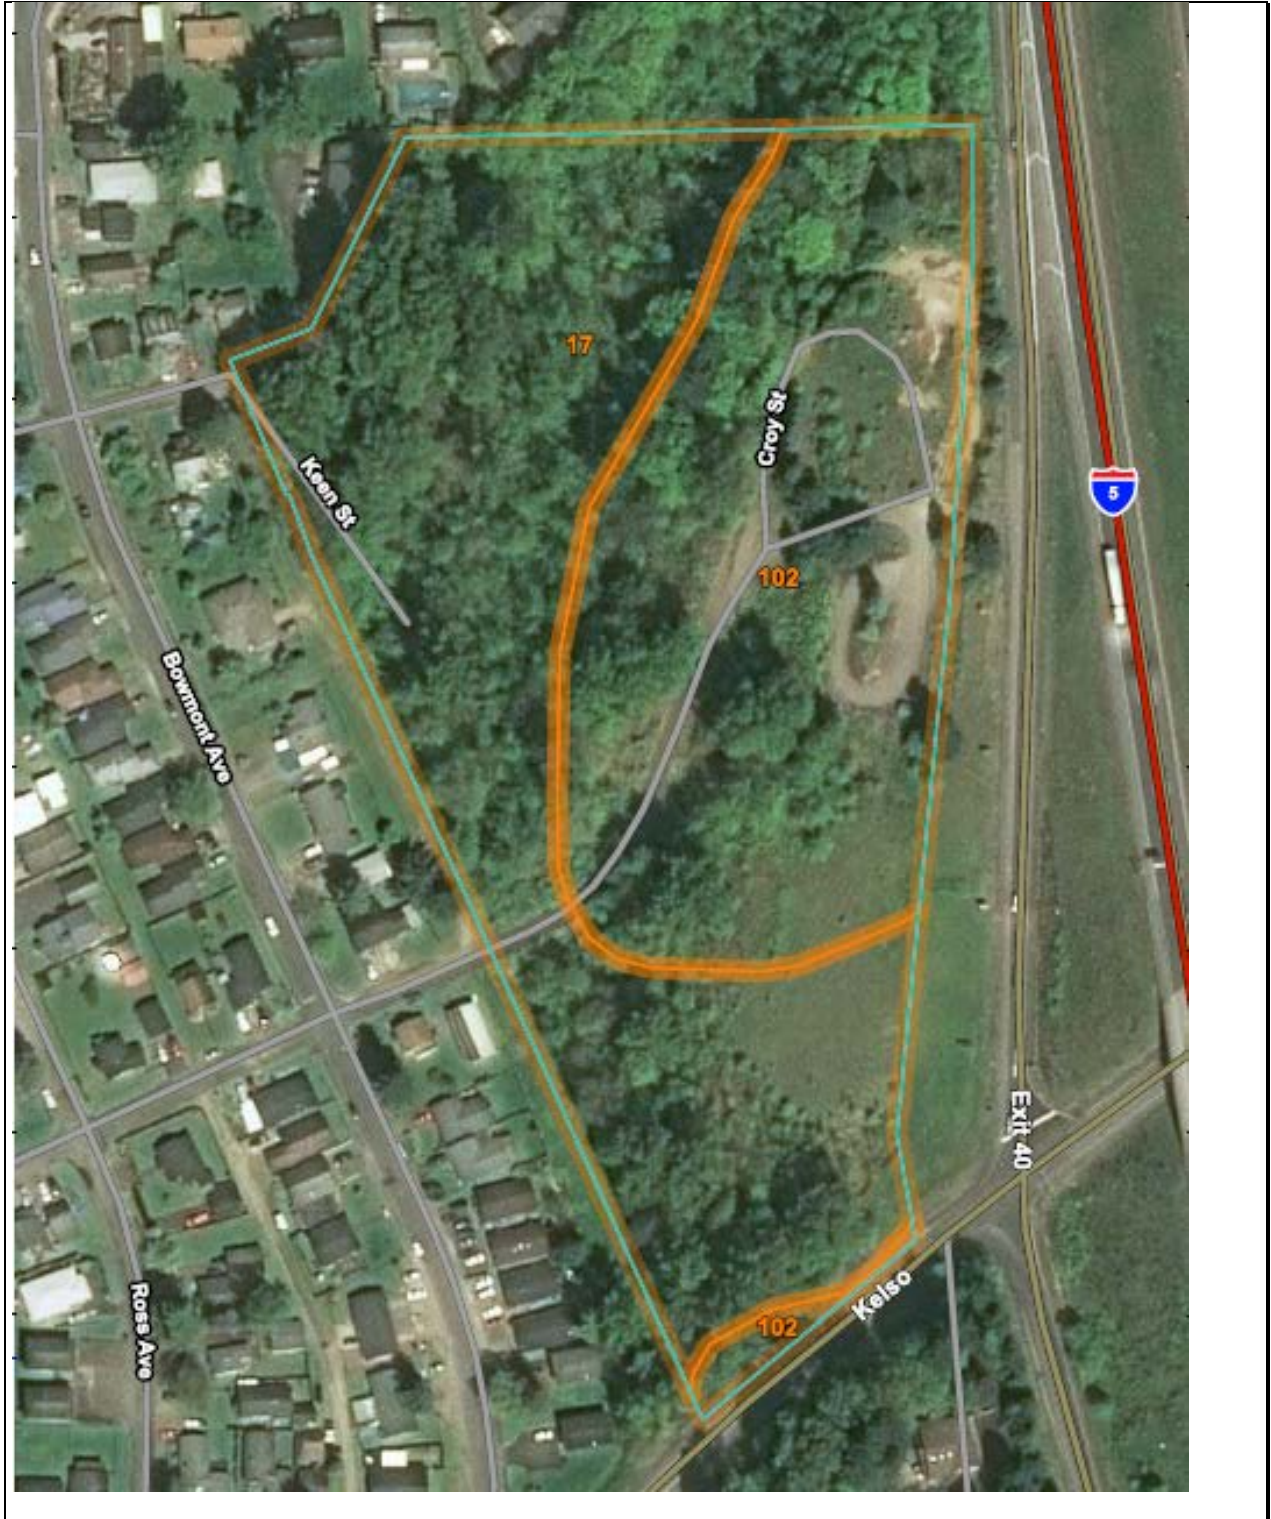
2. SOILS MAP

USDA SCS Map

Site Soils include: Caples silty clay loam, 0 to 3 percent slopes (17) and Kelso silt loam, 15 to 30 percent slopes (102).

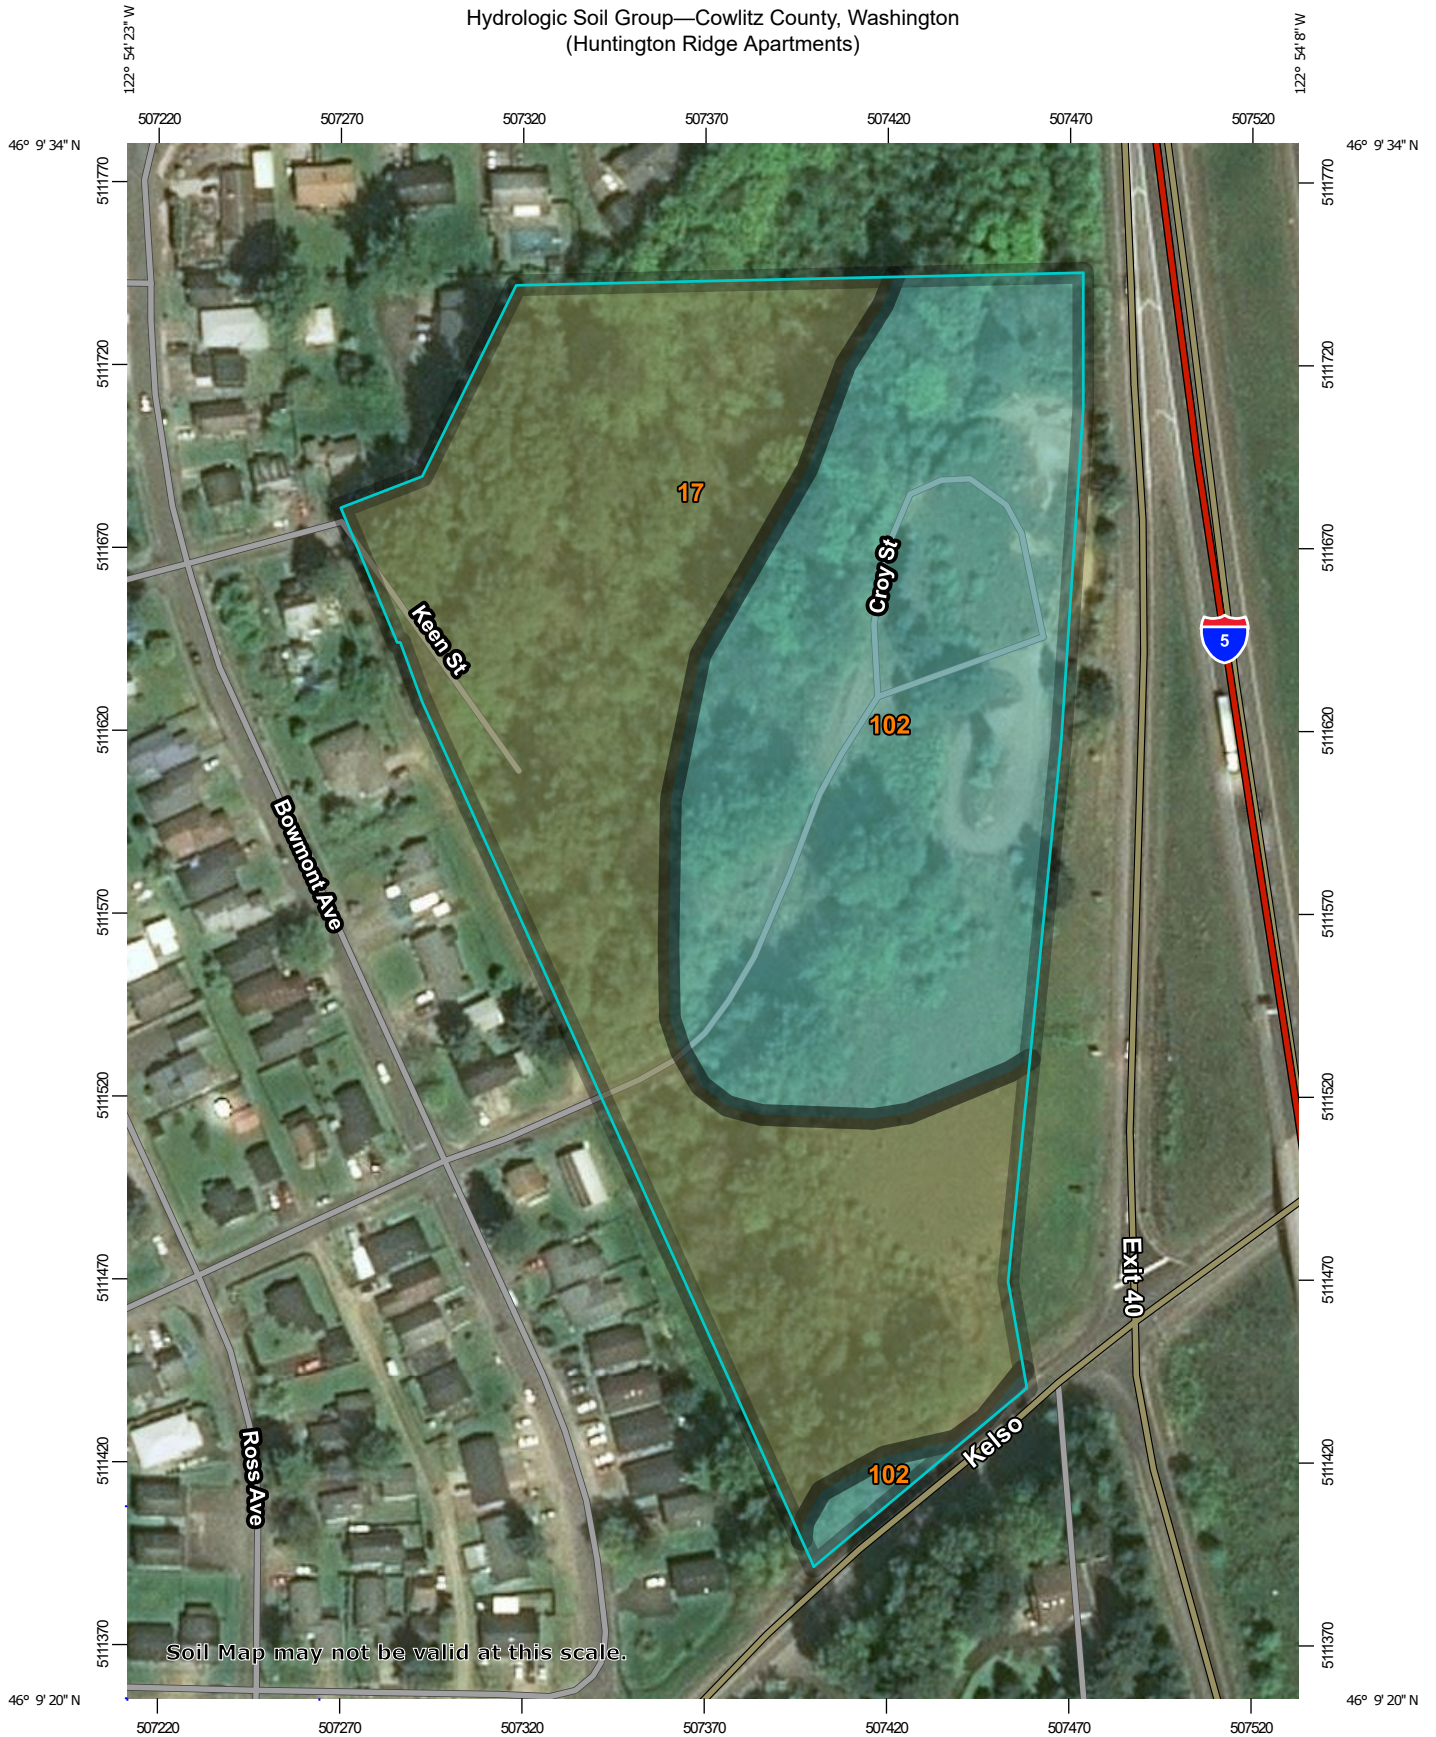
Hydrologic Soil Group—Cowlitz County, Washington
(Huntington Ridge Apartments)

Hydrologic soil groups are based on estimates of runoff potential. Soils are assigned to one of four groups according to the rate of water infiltration when the soils are not protected by vegetation, are thoroughly wet, and receive precipitation from long-duration storms.

Group A. Soils having a high infiltration rate (low runoff potential) when thoroughly wet. These consist mainly of deep, well drained to excessively drained sands or gravelly sands. These soils have a high rate of water transmission.

Group B. Soils having a moderate infiltration rate when thoroughly wet. These consist chiefly of moderately deep or deep, moderately well drained or well drained soils that have moderately fine texture to moderately coarse texture. These soils have a moderate rate of water transmission.

Group C. Soils having a slow infiltration rate when thoroughly wet. These consist chiefly of soils having a layer that impedes the downward movement of water or soils of moderately fine texture or fine texture. These soils have a slow rate of water transmission.

Group D. Soils having a very slow infiltration rate (high runoff potential) when thoroughly wet. These consist chiefly of clays that have a high shrink-swell potential, soils that have a high water table, soils that have a claypan or clay layer at or near the surface, and soils that are shallow over nearly impervious material. These soils have a very slow rate of water transmission.

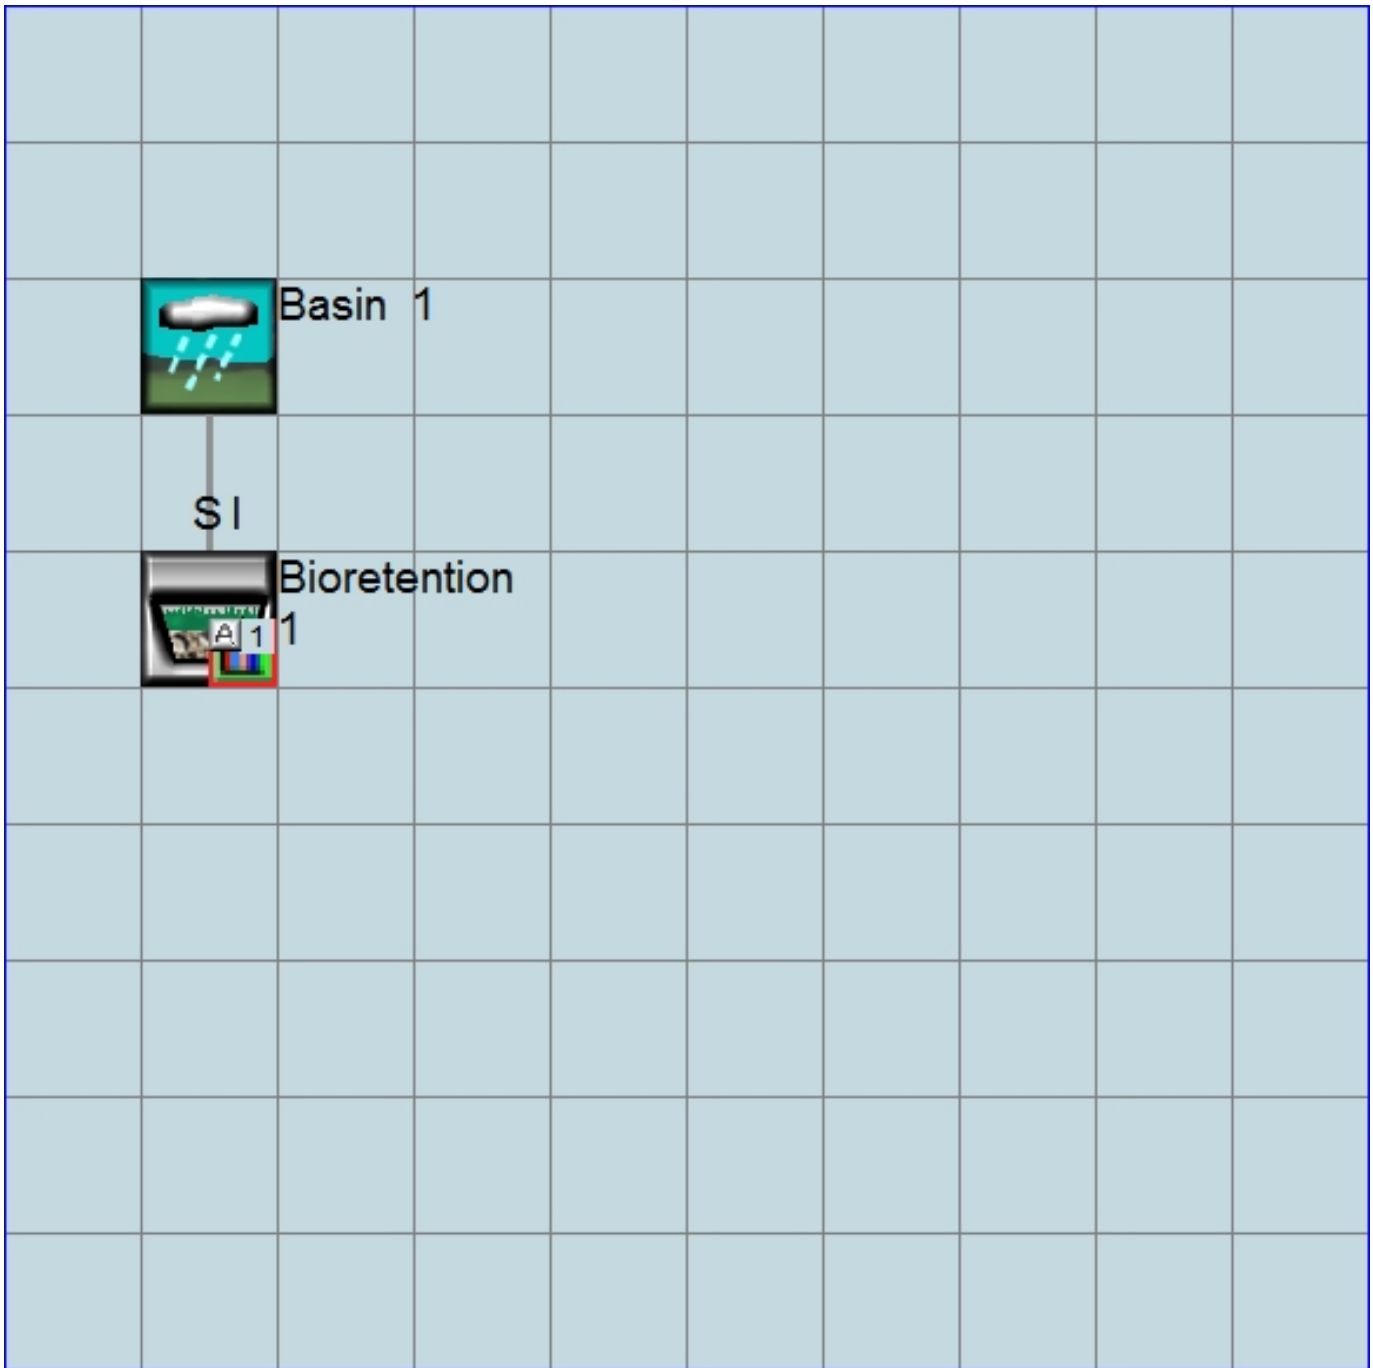
Mitigated Schematic

Stormwater modeling for the water quality treatment facilities will be completed using the Western Washington Hydrology Model (WWHM). Representative calculations for the BRF's located in the landscape islands have been provided in Appendix B of this report. A total of 4,000 square feet of pavement, sidewalk, and landscaping area will drain to each individual BRF. Other methods of water quality treatment may be implemented during the final design depending on topography and other site conditions. It should be noted that the stormwater runoff from the roof has will bypass the water quality facilities.

The BRF's will have side slopes equal to or flatter than 3:1, or will utilize the back of the vertical curb as the sidewall, and will be sized for a depth of storage of between 0.5' and 1' for the water quality event, as previously stated. The infiltration rate of the BSM is assumed to be the standard SMMWW 12 in/hr rate that is built into the WWHM. The standard SMMWW soil type will be utilized for the soil material in the BRF and a safety factor of 2 has been applied to the infiltration rate since less than 5,000 square feet of pollution generating impervious surfaces will drain to the facility. As shown on page 6 of the WWHM report included in Appendix B, the BRF's will successfully filtrate 91.81% of all tributary runoff through the bioretention soil mix. This exceeds the SMMWW requirement that at least 91% of all runoff be infiltrated through the treatment soils.

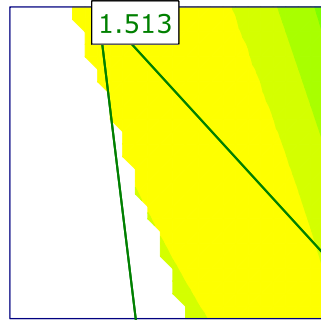
SLOPE STABILITY ANALYSIS RESULTS - STATIC

Material Name	Color	Unit Weight (lbs/ 3)	Strength Type	Cohesion (psf)	Phi (deg)	Water Surface	Ru
Loose Sand		125	Mohr-Coulomb	0	32	None	0
Medium Dense Sand		125	Mohr-Coulomb	0	37	None	0

We used the software SLIDE 2018 version 8.011 developed by Rocscience Inc., of Toronto, Ontario, Canada to evaluate the cross section. The software uses Spencer's method of slices to evaluate the static equilibrium of the model for both force and moment equilibrium while assuming that resultant inter-slice forces are of constant orientation throughout the sliding mass. This method of analysis is valid for circular and non-circular failure surfaces.

The internal friction angles (ϕ), moist unit weights, and cohesion intercepts assigned to each unit are included with the results provided with the A-A' cross section in Figures 5a & 5b. The values were chosen conservatively based on generally accepted correlations with soil texture, and standard penetration tests conducted in the soil borings.

The limits of the static and pseudo-static analysis were adjusted until factors of safety were greater than the generally accepted minimum factors of safety of 1.5 and 1.1, respectively, for existing or engineered slopes. Failure planes at these minimum factors of safety were found to be located at a minimum distance of 25 feet from the top of the steepest northwest slope. The graphical output of the slope model analysis for static and pseudo-static (seismic) is provided with the A-A' cross sections in Figures 5a & 5b, respectively.

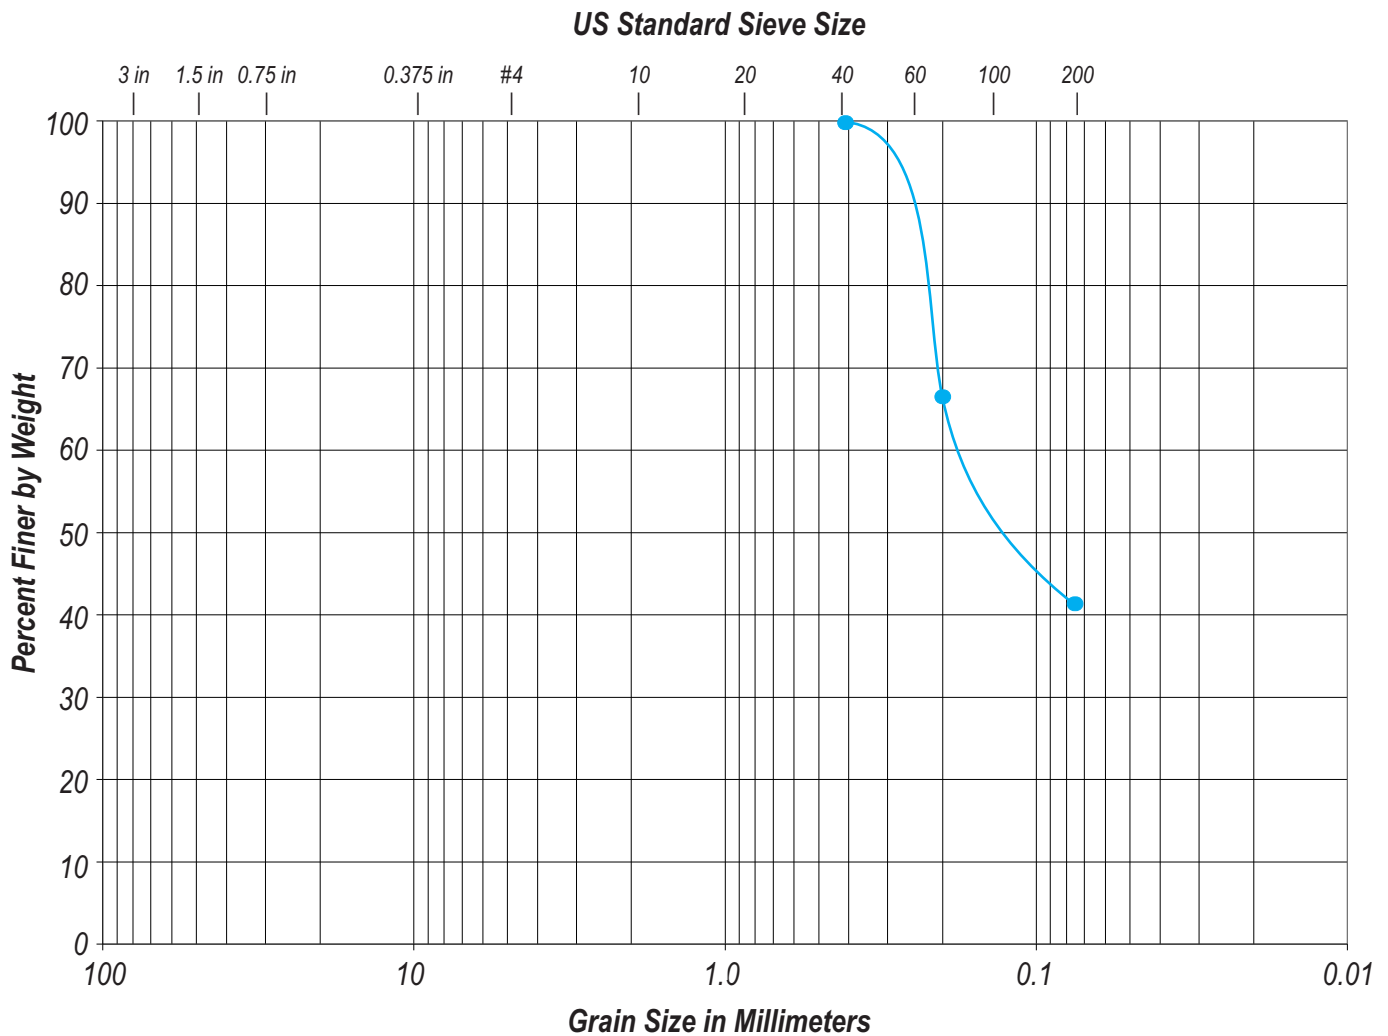
GRAIN SIZE DISTRIBUTION

B-1 at 20 feet
 Native fine silty Sand (SM)
 with 42% passing the #200 Sieve
