Huntington Middle School Modernization

Geotechnical Engineering Report

Huntington Middle School Renovation and Gymnasium Addition
500 Redpath Street
Kelso, Washington

July 7, 2020
PBS Project 73400.004

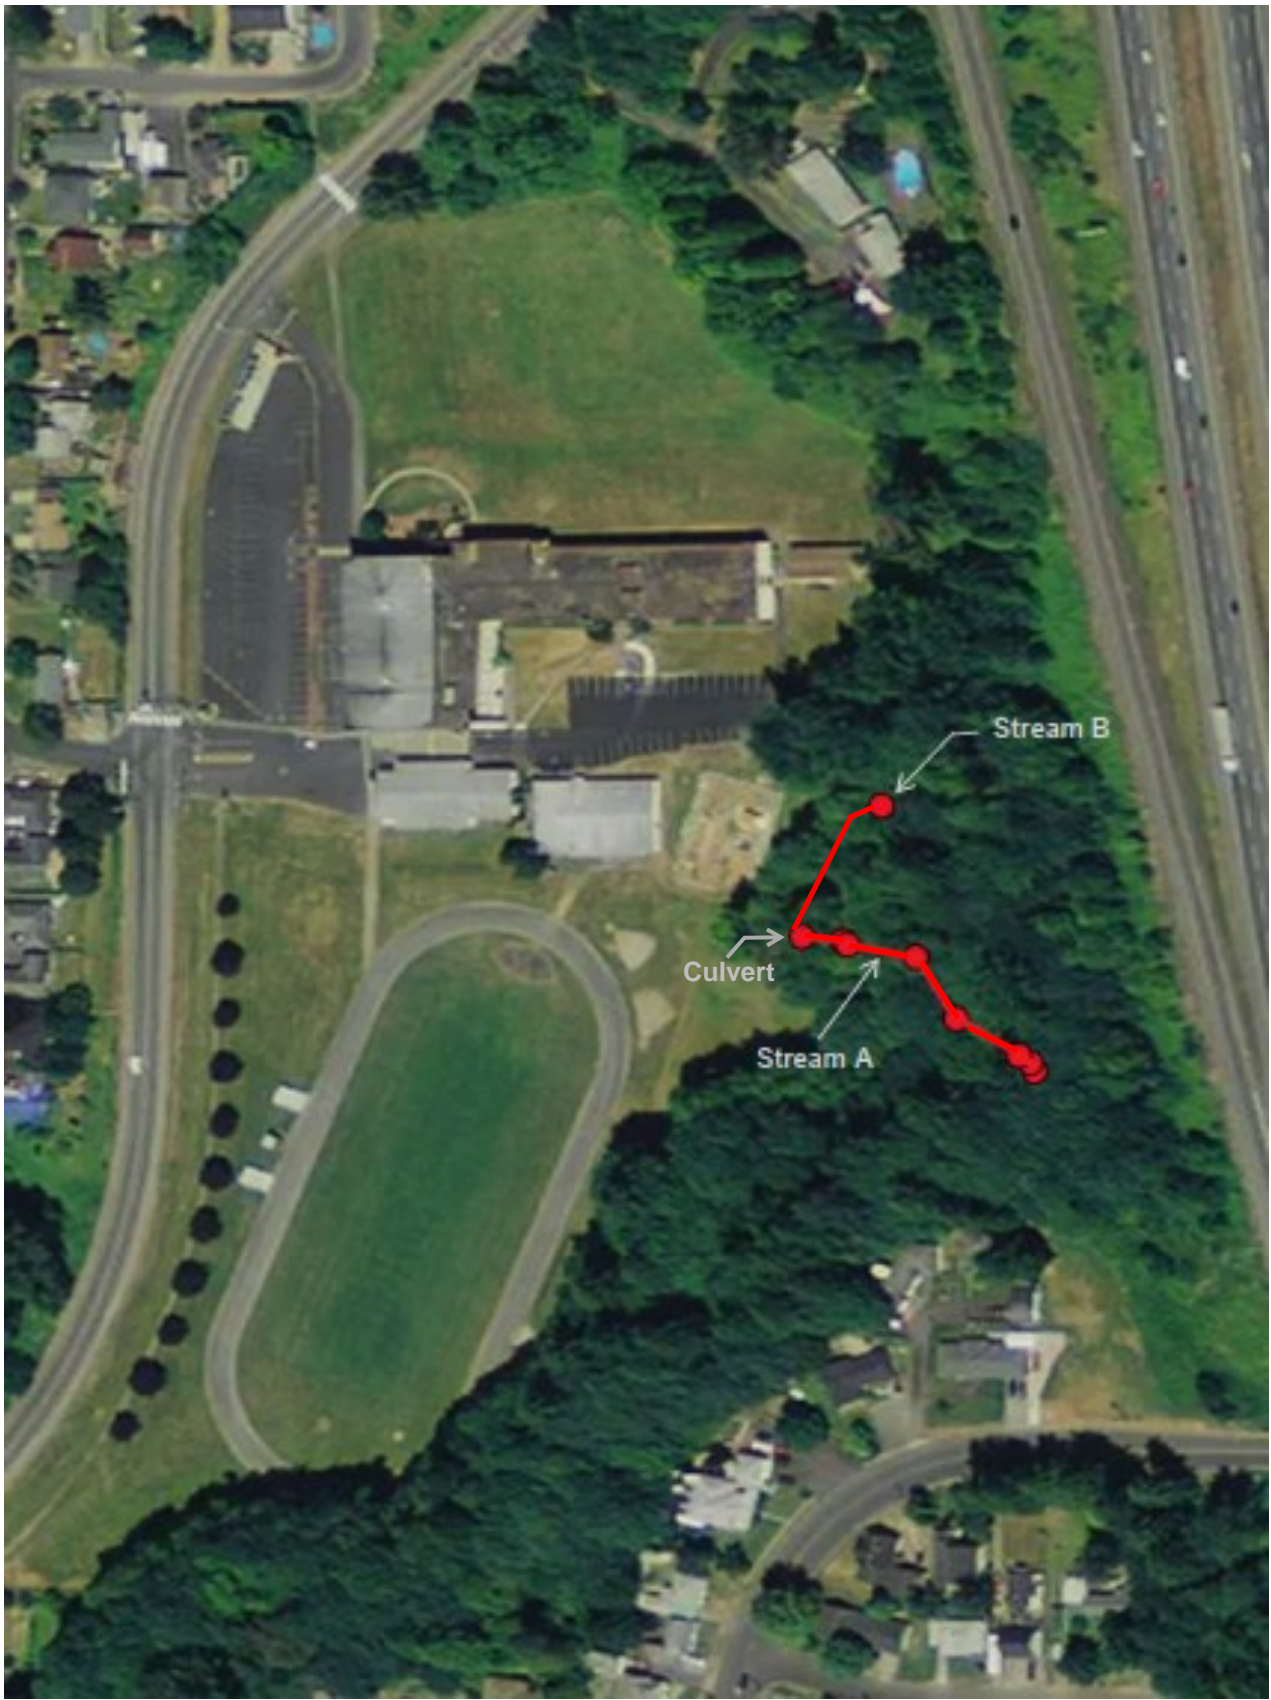
Figure 1
Site Map
Huntington Middle School Memorandum
Kelso School District
Cowlitz County, Washington

The study area mainly consists of the forested area behind (east) of the Huntington Middle School campus (Figure 1). The study area slopes from east to west and contains small ravines. The study area is forested largely with native species, consisting mainly of include red alder (*Alnus rubra*), Douglas fir (*Pseudotsuga menziesii*), and big leaf maple (*Acer macrophyllum*). The understory contains native shrubs and herbaceous species including sword fern (*Polystichum munitum*), vine maple (*Acer circinatum*), salmonberry (*Rubus spectabilis*), and Indian plum (*Oemleria cerasiformis*); however, Himalayan blackberry (*Rubus armeniacus*) and English ivy (*Hedera helix*) dominate the understory. Interstate-5 lies directly east of the forested area with school buildings, athletic fields, and maintained school grounds to the west. Two streams (Stream A and Stream B) were delineated within the study area. The streams converge at a culvert located at the western edge of the forested area adjacent to the maintained grounds that conveys water to the west/northwest.
